Mining Warden
Yallourn Mine Batter Failure Inquiry

Mining Warden - Yallourn Mine Batter Failure Inquiry

EXECUTIVE SUMMARY

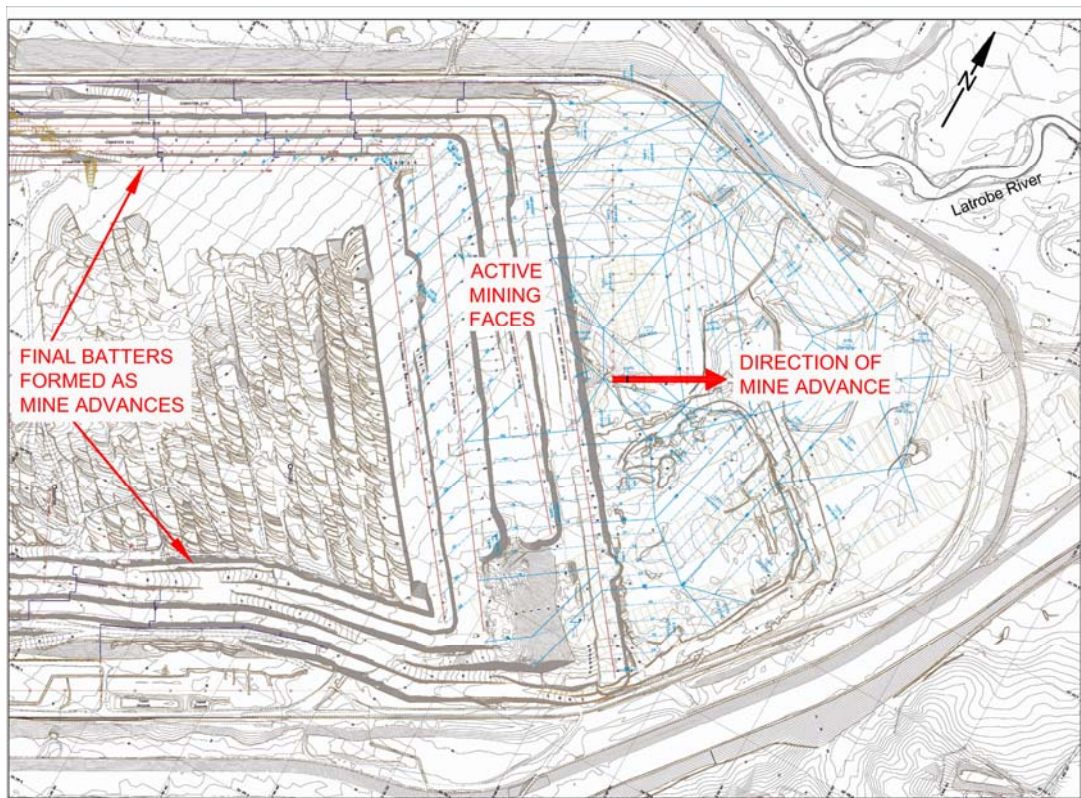
Figure 1: Yallourn East Field – 2002

The Yallourn East Field Mine (YEF) was approved in 1996 and commenced mining in the southwest advancing towards the northeast. Final batters were formed progressively on the north western and south eastern sides as the mine advanced. The active mining faces which were formed by “dredgers” (bucketwheel excavators) were located on the north eastern side of the mine and were much flatter than the final batters to allow for the mining to take place, Figure 1.

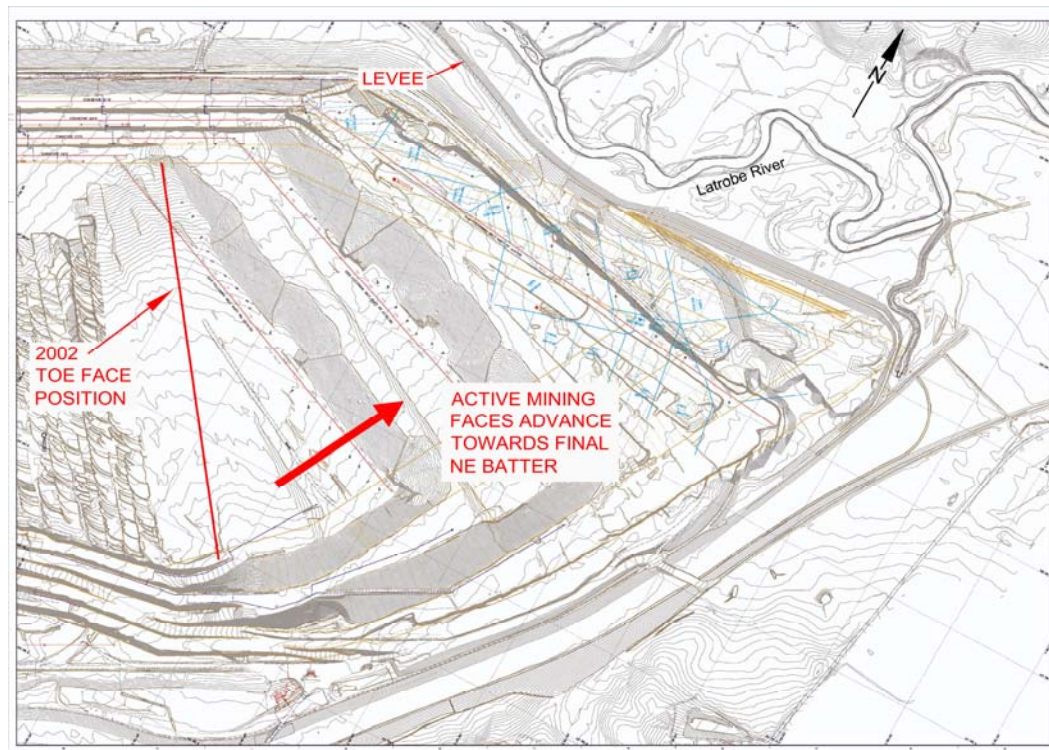
Figure 2: Yallourn East Field March 2005

In 2002 a change to the mining layout and system was approved by DPI. The dredgers were progressively replaced by bulldozers and feeder breakers (FB1 to FB4). There was also a change in the orientation of the northern batter, from the northeast-southwest alignment to east-west, Figure 2. This east-west alignment is the final NE Batter which includes where the failure occurred. The active mining benches were then pivoted about their north western contact point with the northern batter and swivelled towards the north. These active mining faces then advanced towards the final NE Batter. The final NE Batter comprised three benches and the approximate time period over which each was completed comprises:

It is believed the limitations referred to above relate to being able to install horizontal bores in the new higher coal batters, Figures 2 and 3.

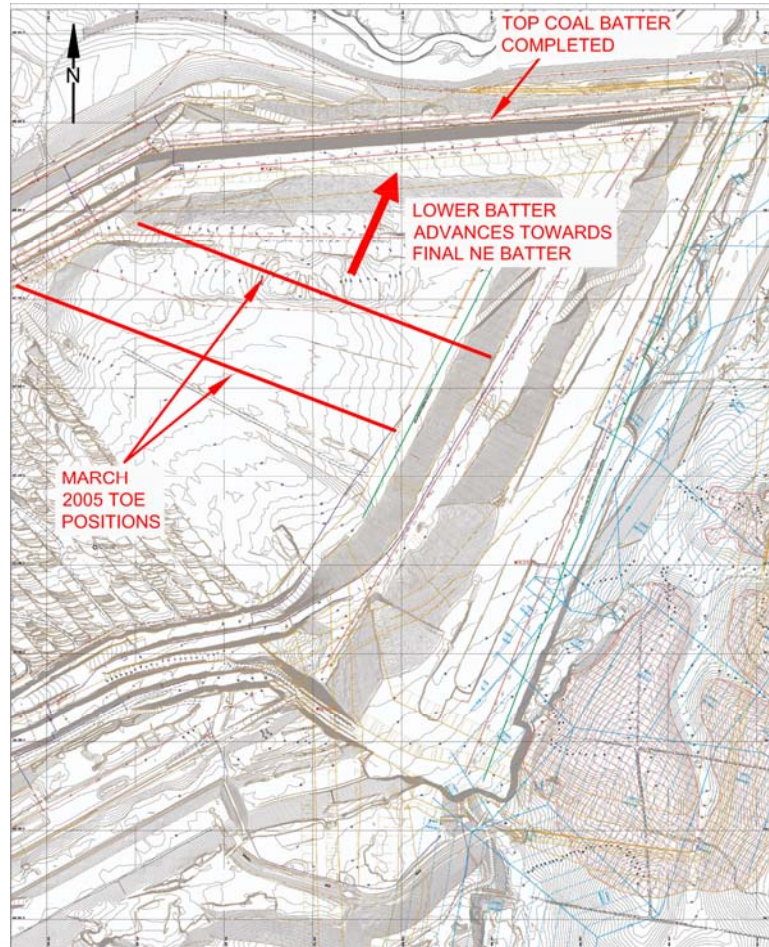
Figure 3: Yallourn East Field - June 2007

1. Upper overburden and coal batter – September 2005 to June 2006.
2. Middle bench – December 2005 to June 2007, Figure 3.
3. Lower bench – June 2007 onwards, with a small wedge of coal remaining at the eastern end of the NE Batter at the time of the failure, Figure 4.

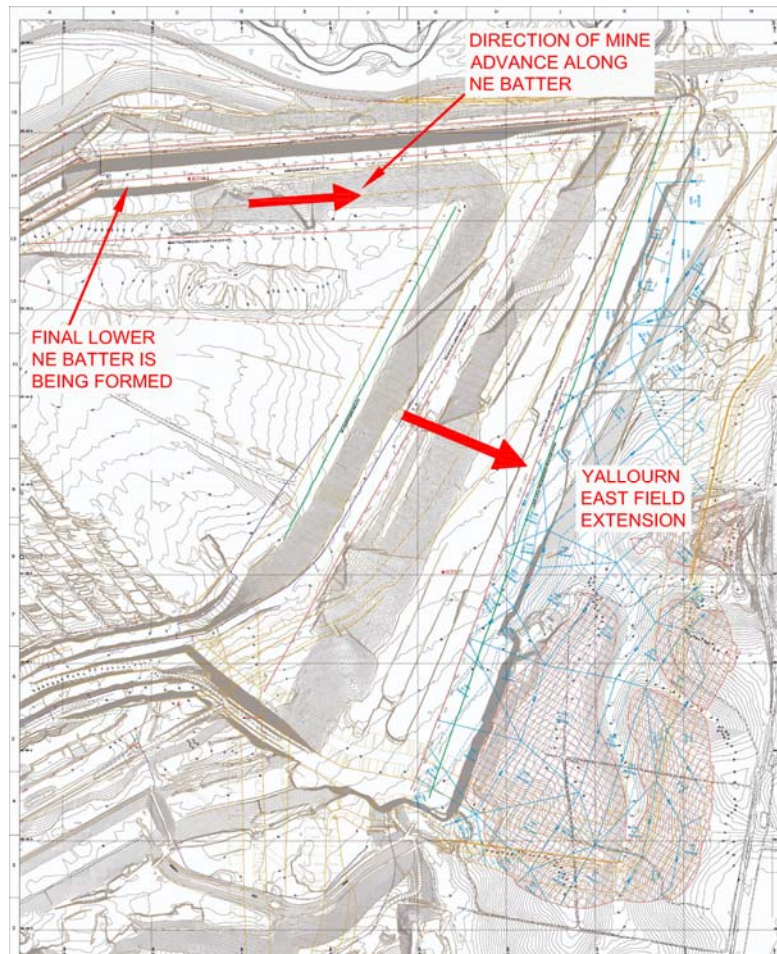
Figure 4: Yallourn East Field – September 2007

The final slice of coal remaining along each bench was excavated by advancing from west to east along the NE Batter, Figure 4.

1. Because the final NE Batter was continually being excavated, from September 2005 till the failure, there was no effective time when excavation was completed from a mining viewpoint. Hence the final batter was not formed until almost the end of mining. I consider this could make it more difficult to evaluate the slope movement monitoring data.
2. The dominant joint sets in the coal in the YEF are aligned west northwest to east southeast and form an acute angle with the NE Batter, refer to Section 8.4. Because each bench of the final batter was formed by excavating from west to east, Figure 4, these joints did not “daylight” in the final batter (that is form an intersection with the final batter) until the excavation had advanced towards the eastern end of the NE Batter. Hence

there was limited opportunity for natural drainage of water pressures out of the joints to occur.

3. The combination of the increased individual bench heights and the direction of advance of the mining faces meant it was more difficult, compared to the pre-2002 mining system and layout, to install an effective horizontal bore system.
4. Implementation of a groundwater system for control of groundwater levels in and below the NE Batter would have been more difficult.

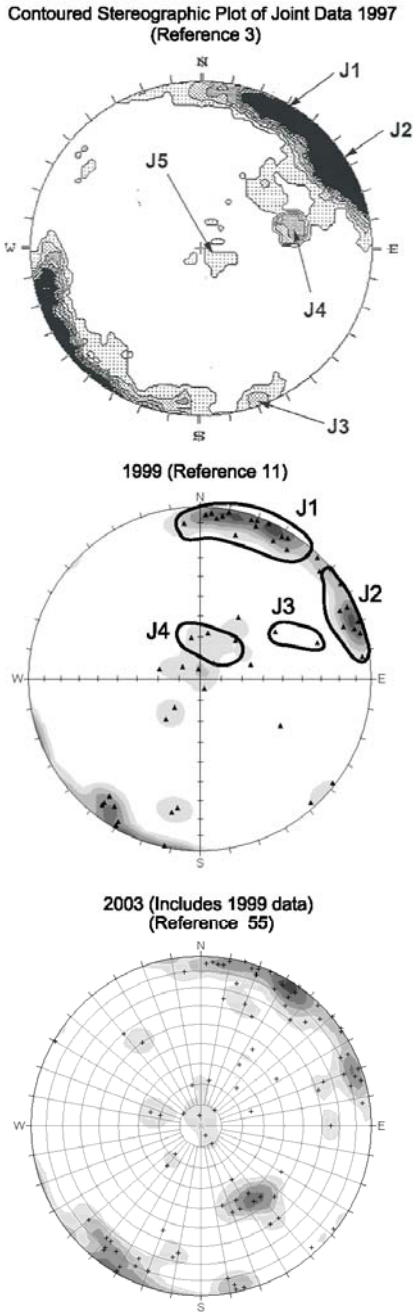
Figure 5: Contoured Stereographic Plots of Joint Data 1997, 1999 and 2003 (References 3, 11 and 55). Note the patterns are consistent for the three sets of data.

In 1997 a geological survey of the YEF was carried out and the survey identified the joint sets in Table 8.1 and as shown in Figure 5 (Reference 3). It is noted that the two joint sets that are sub-parallel to the NE Batter, J1 and J2, are noted as:

A further geological joint survey was carried out in April 1999 (Reference 11). The results of that survey are included in Table 8.2 and shown in Figure 5:

“Joints sets J1 and J2 are very continuous and appear to penetrate the entire coal seam in which they are located. These joints are planar with smooth and clean surfaces.”

Further mapping was undertaken in 2003 as part of a thesis at RMIT under the supervision of BFP (Reference 55), Figure 5.

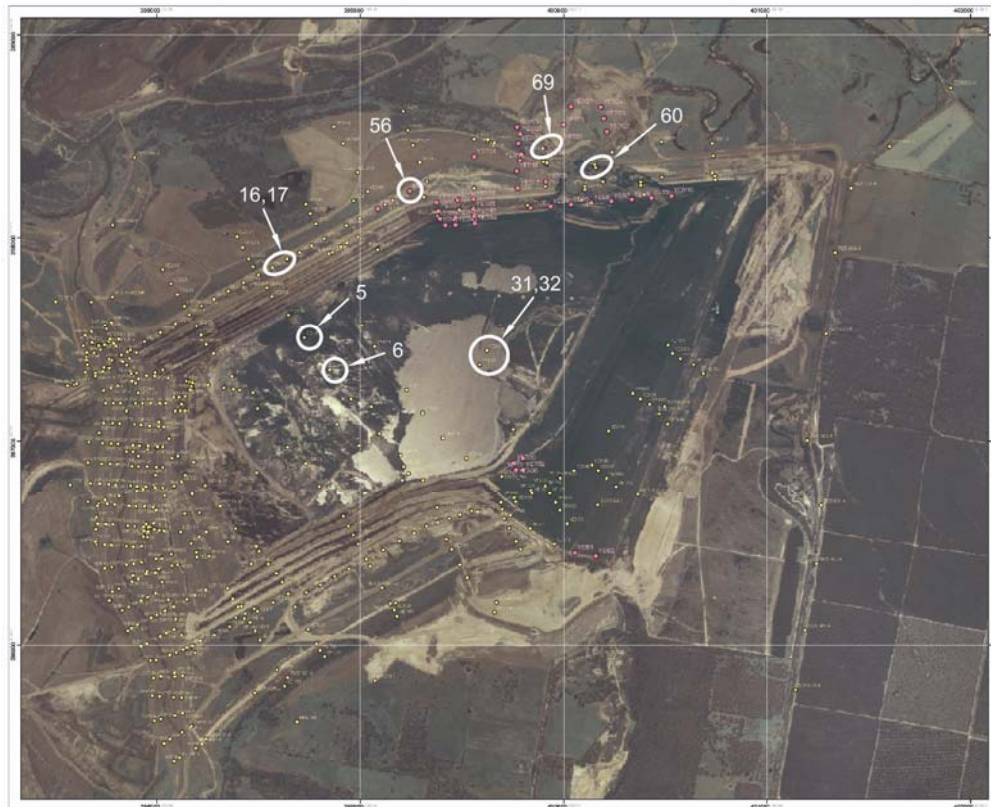
Figure 13: Movement pins YEF

- 10 November – Water in Bore 25846, which is located where the failure occurred, rises by 15m, Figure 13. I note this is a substantial rise.
- 11 November – Internal note to file by Mine Geologist “Water Inflow Latrobe River batters November 2007.”

There was an extensive network of pins monitoring the mine floor in the area mined up to about 2002, Figure 13. However at the time of the failure only three floor pins, YE4_29 to YE4_31, were being monitored in the eastern part of YEF.

This shows the eastern end of the YEF has been subject to long term upward creep of the floor probably due to groundwater pressures.

The batters and areas behind the final NE Batter were also monitored with pins, Figure 13. There are a number of long term pins that illustrate the movement of the batter over time, including YE2_55, YE2_56 and E110_slab. Figure 15 shows the movement trend for YE2_56. This pin shows long term accelerating movement with a pronounced acceleration starting in early 2005. The acceleration and movement had been occurring over many years prior to the failure. The total magnitude of movement is also relevant and is approaching 2m.

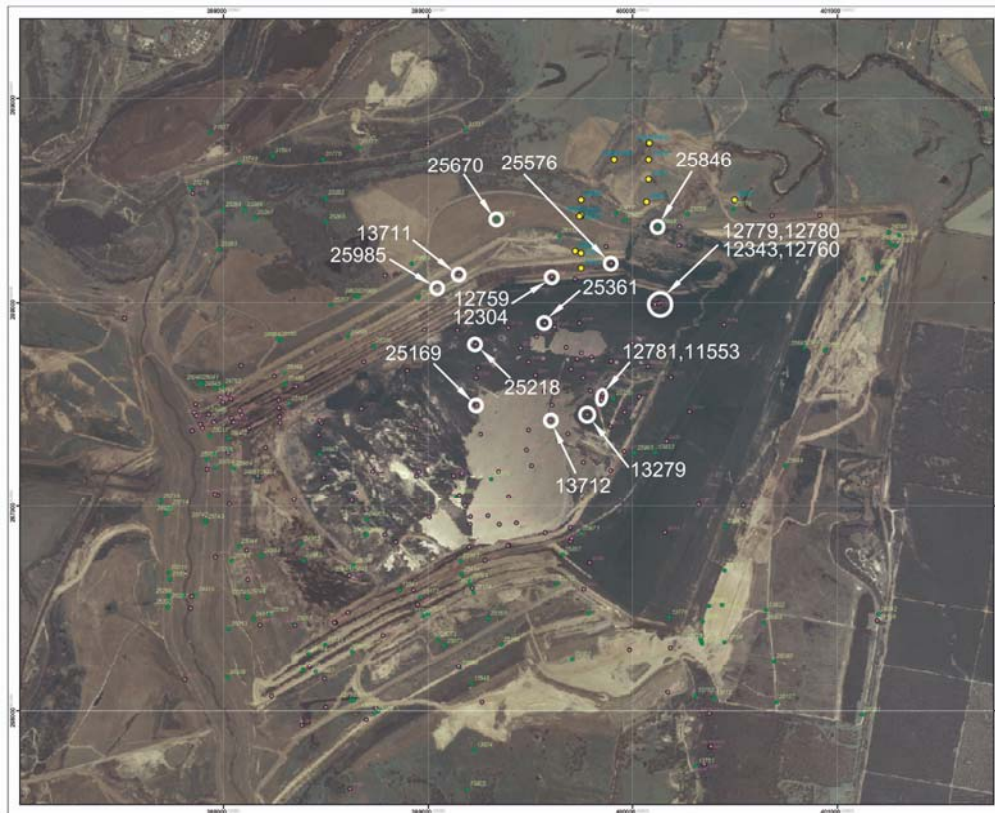
Figure 17: Piezometer locations around the NE Batter

The piezometer locations are shown in Figure 17. The groundwater level (piezometric) data for the NE Batter area is shown in Figure 18. The data extends from about mid 1998 till the time of the failure. These piezometers are also included in Figure 19 for the period from 2004 till immediately after the failure.
